Mapping Inundation extent for Kurunegala District in North Western Province (Sri Lanka) using ALOS 2 PALSAR 2 Satellite Data (23 May 2018)

23 May 2018 | FL-2018-0006-SL |

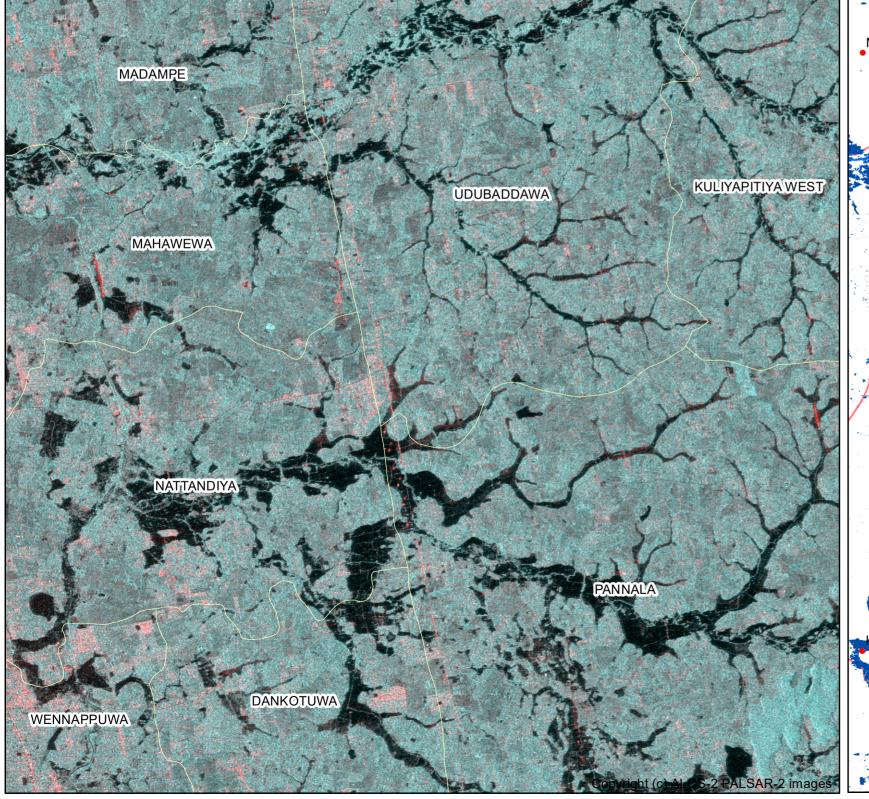
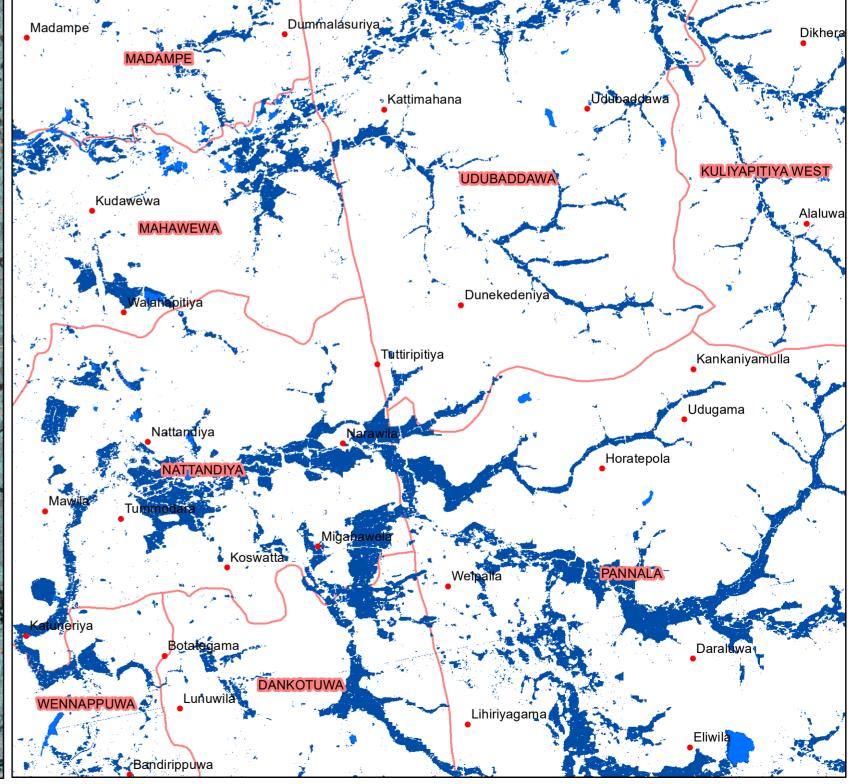
The initial satellite observations from ALOS-2 PALSAR-2 (23 May 2018) showed vast areas of standing flood waters along the North Western, Western and Southern Provinces. Initial estimates from satellite images indicate that Puttalam (96.1 sq.km), Kurunagala (198.6.sq.km), Gampaha (82.46 sq.km) Galle (25.5 sq.km, Kaluthara (22.1 sq.km), Rathnapura (10.4 km.sq), Colombo (4.2 sq.km). Most of the district flood is reducing but rivers are still under minor flood level.

The satellite image from ALOS-2 PALSAR-2 taken on 23 May2018 showing considerable inundation for Galle and reference to dark with deep water and dark grey color in the agriculture fields with water.

The analysis excluded permanent water bodies including reservoir, tanks and ponds and this reflects only the inundation extent. Please note the surface water extent mapped has not yet been validated in the
